# **SPECIFIC STRUCTURAL REPORT**

**Survey Address**

**Wednesbury  
West Midlands**

**2011**

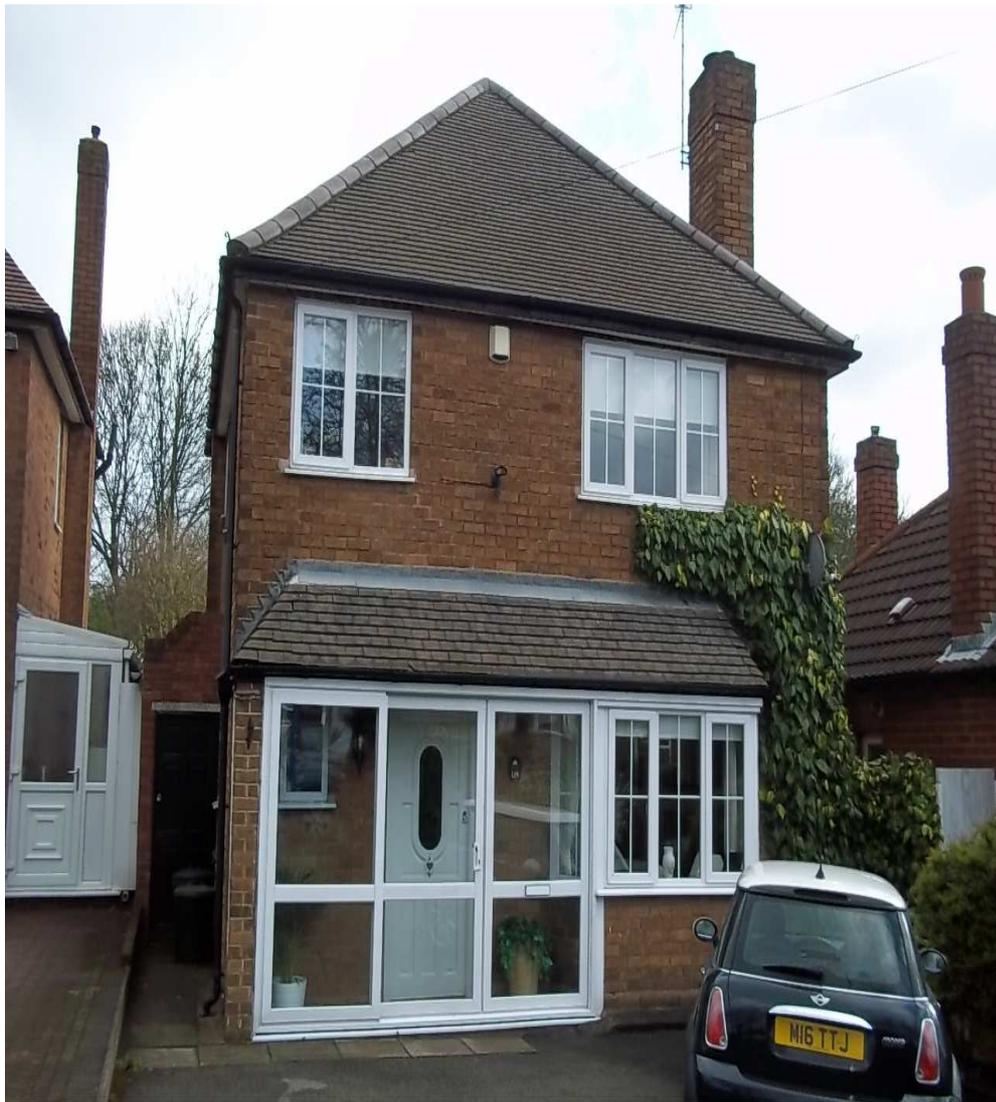
**FIGURE 1**

Photograph of the front elevation of the house, porch.

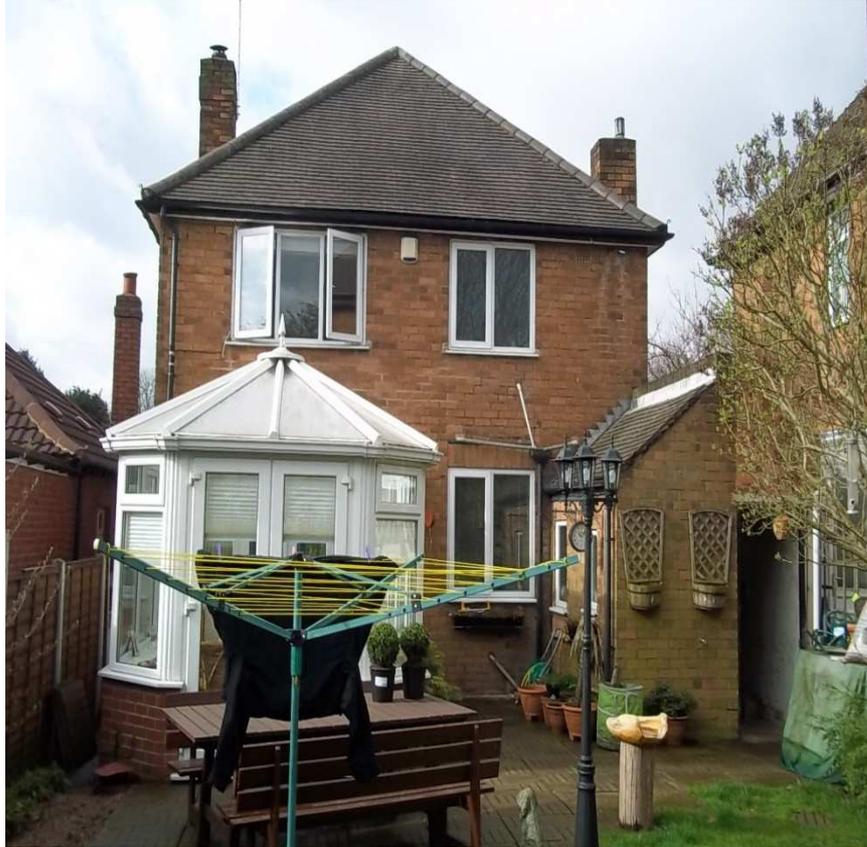
**FIGURE 2**

Photograph of the rear elevation of the house, conservatory and utility room.

- The wall is fairly vertical.
- All the repaired cracks have not re-opened.
- There is a diagonal crack 1mm wide to the right hand elevation of the utility room. The crack is approximately 6 course long above the window lintel.

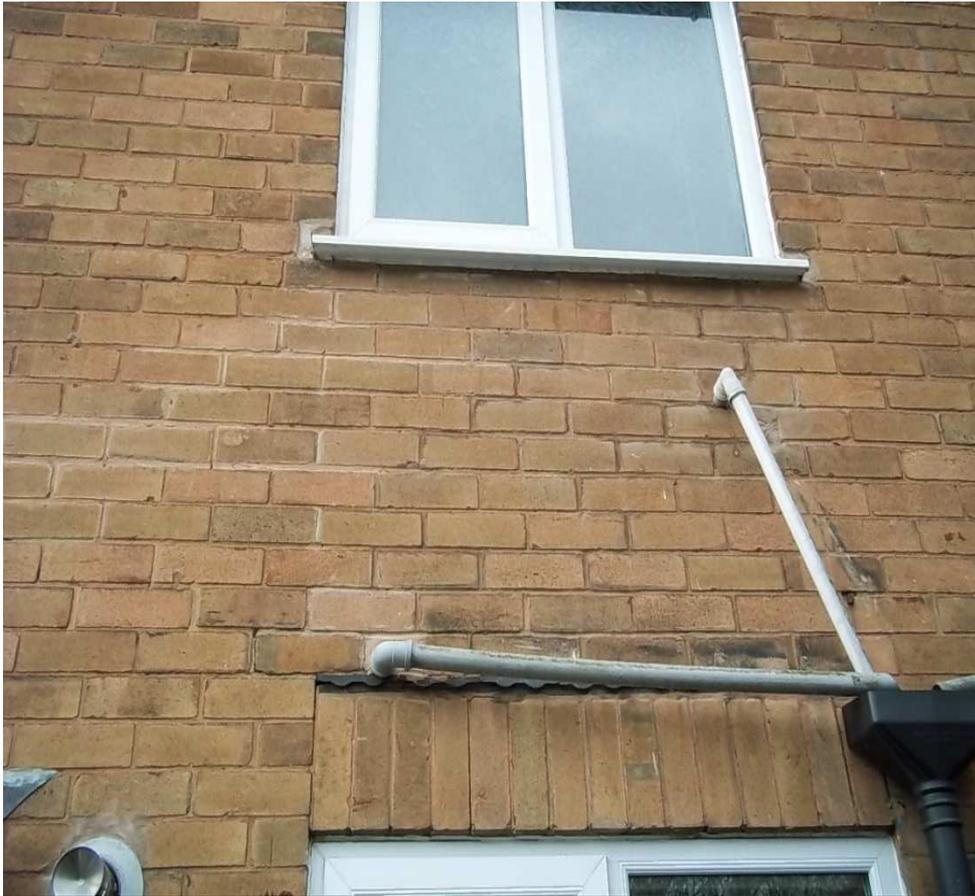
**FIGURE 3**

Photograph of crack repairs completed at the rear elevation of the house.

The cracks externally were repaired with masonry stitch bars and the areas re-pointed. The internal damage was plastered and those rooms re-decorated. Since that time neither the external or internal cracking has reoccurred. There are two lintel failures evident at the property but that damage is not structurally significant. Those cracks can be re-pointed.

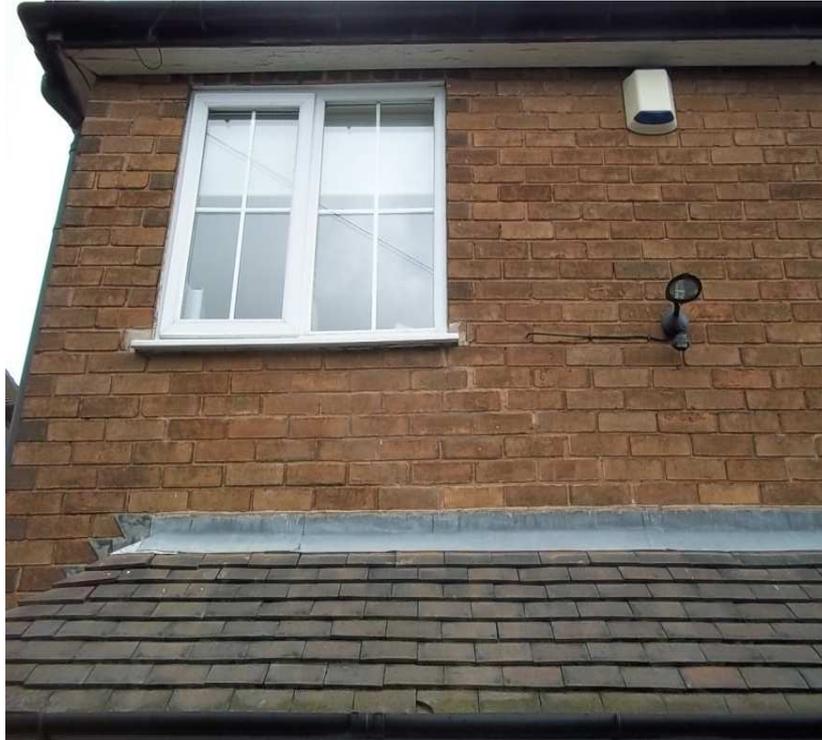
**FIGURE 4**

- The front elevation of the main house is fairly vertical.
- The cracks repointed in 1997 have not re-opened.
- There are diagonal cracks above the front door lintel measuring 2-3mm wide. The cracks are approximately 8 courses long.

Crack repairs to the front of the property.
