Harborne Building Consultancy
Structural Surveys and Designs

SPECIFIC STRUCTURAL REPORT

**Erdington
Birmingham**

ENGINEERS REPORT

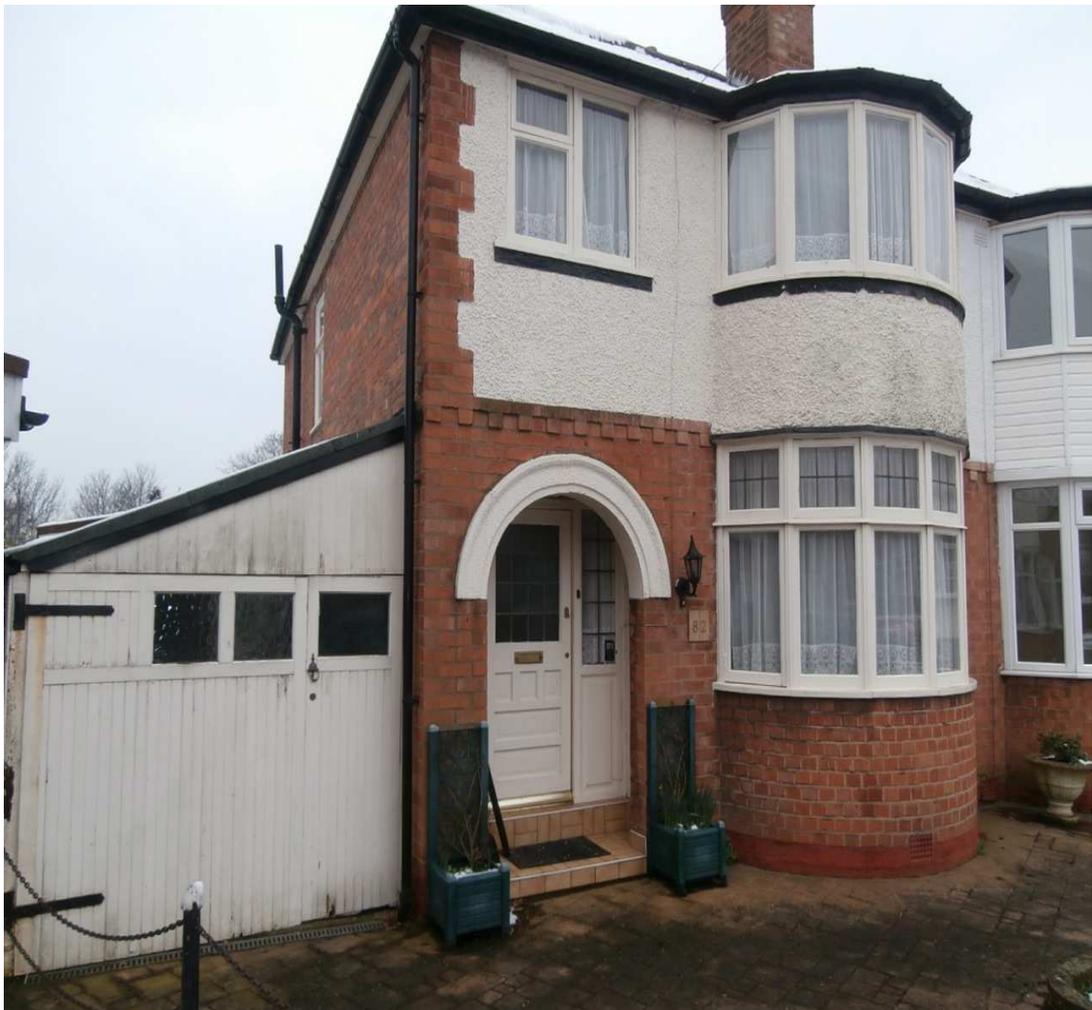
FIGURE 1

Photograph of the front elevation of the property, entrance porch and two storey window bay.

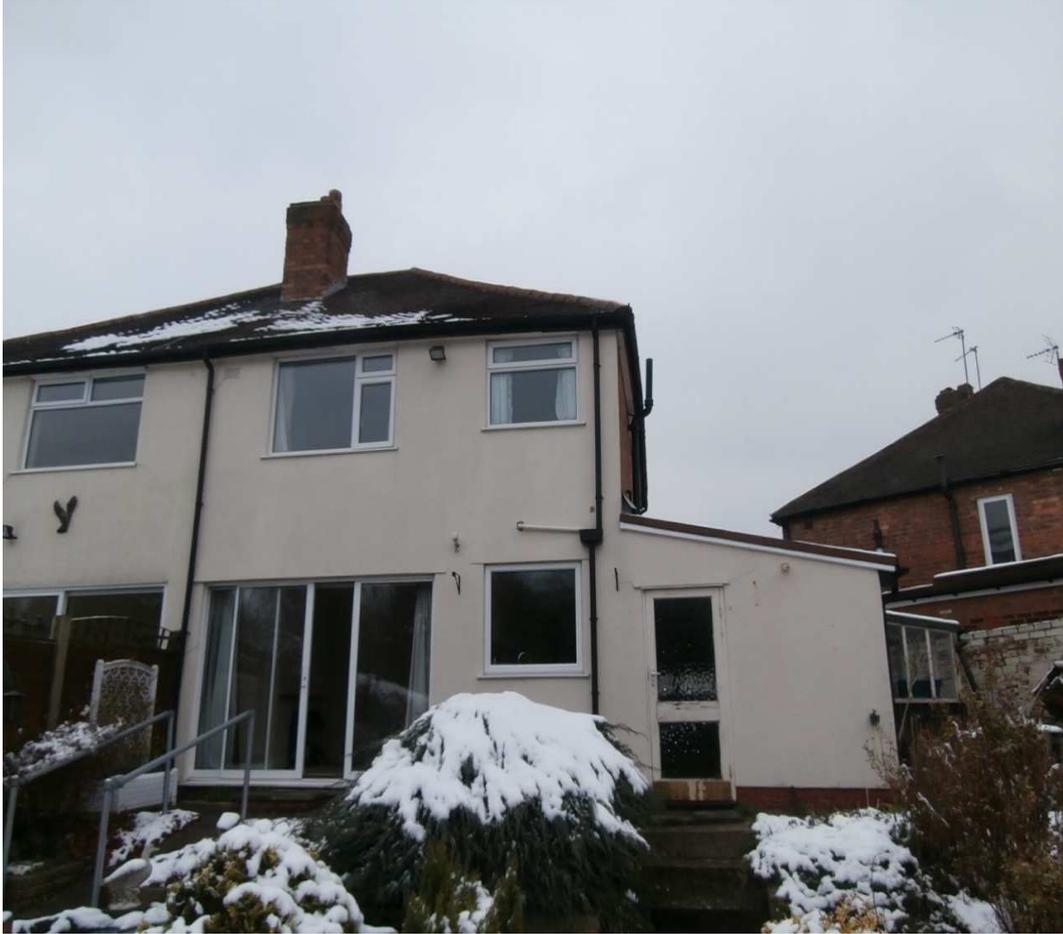
FIGURE 2

Photograph of the rear elevation of the property and left hand outbuildings exit door.

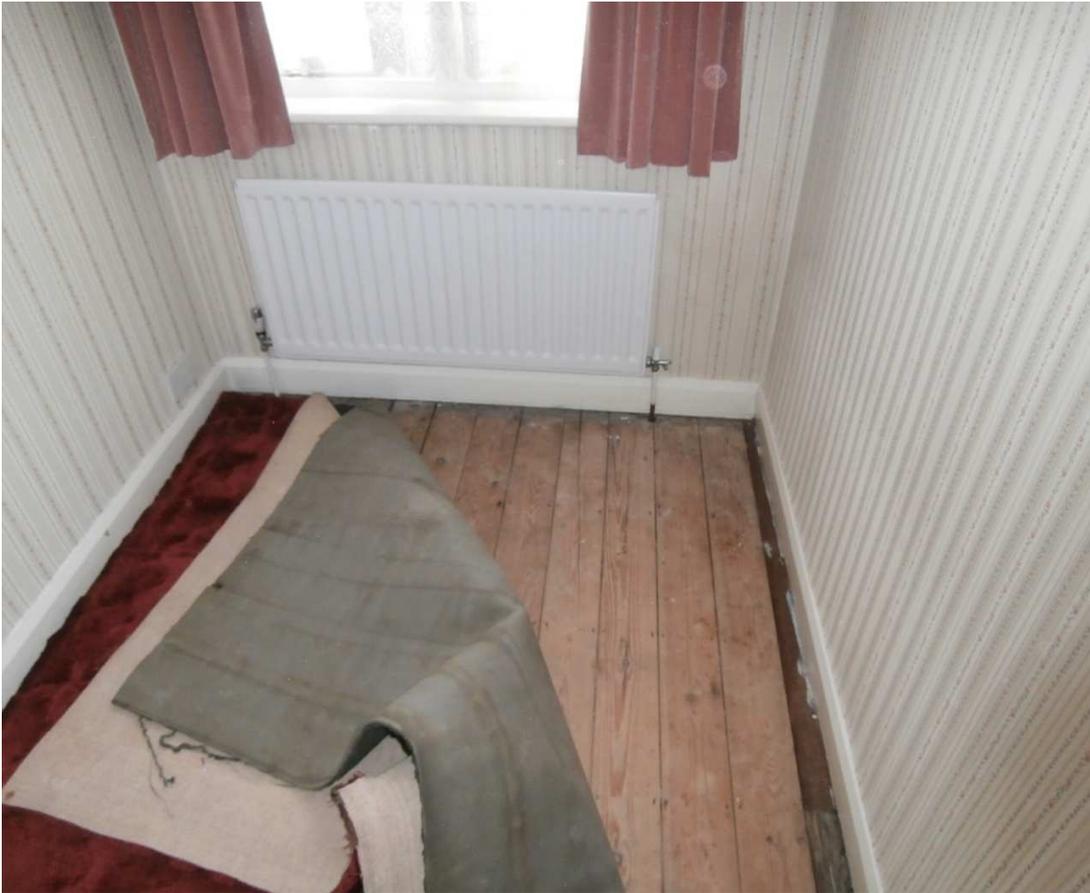
FIGURE 3

Photograph of lateral movement to the front and gable elevations of the front left hand corner bedroom.

In order to stabilise the gable elevation of this property it is normal practice to introduce galvanised steel lateral restraint straps to stabilise the deflected wall. These straps are normally 30mm x 5mm in section and are screwed to the floor joists, the ceiling joists and the rafters and bolted to the wall. The straps are usually spaced at not more than 1.0m centres and in some cases are also fitted to intersecting walls. In the latter case they are again usually spaced at not more than 1.0m centres, measured vertically. However due to the severity of the bowing to the gable elevation of this house I am recommending that Bow and Cem ties are introduced to stabilise that elevation. The front elevation of the property is bowing moderately and both ties will be required to stabilise that elevation.

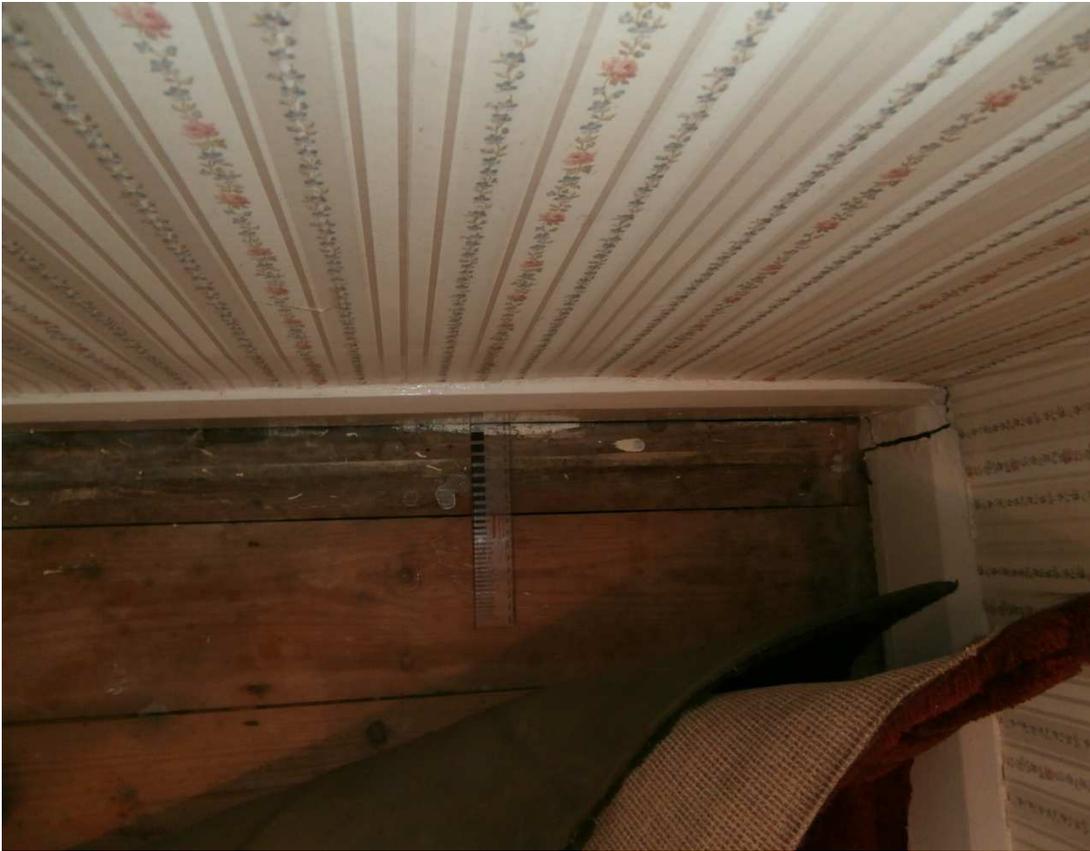
FIGURE 4

Outward lateral movement of the gable elevation of the front left hand bedroom away from the bedroom floor boards.

Outward movement of external walls can be initiated by one or a combination of thermal expansion, wind suction and excessive vertical loading but these forces are only significant in cases where the external wall is inadequately restrained laterally. In cases where there is inadequate lateral restraint to an external wall the wall tends to move outwards slowly over a long period of time and this movement usually remains progressive and will eventually result in the wall becoming unstable. In this case the severity of the bowing to the gable elevation means substantial stabilisation measures will be required. In the section below I am recommending that some Bow ties and Cem ties are introduced to stabilise that elevation. Furthermore there is some moderate bowing to the front elevation and Bow ties will also be required to stabilise that wall.

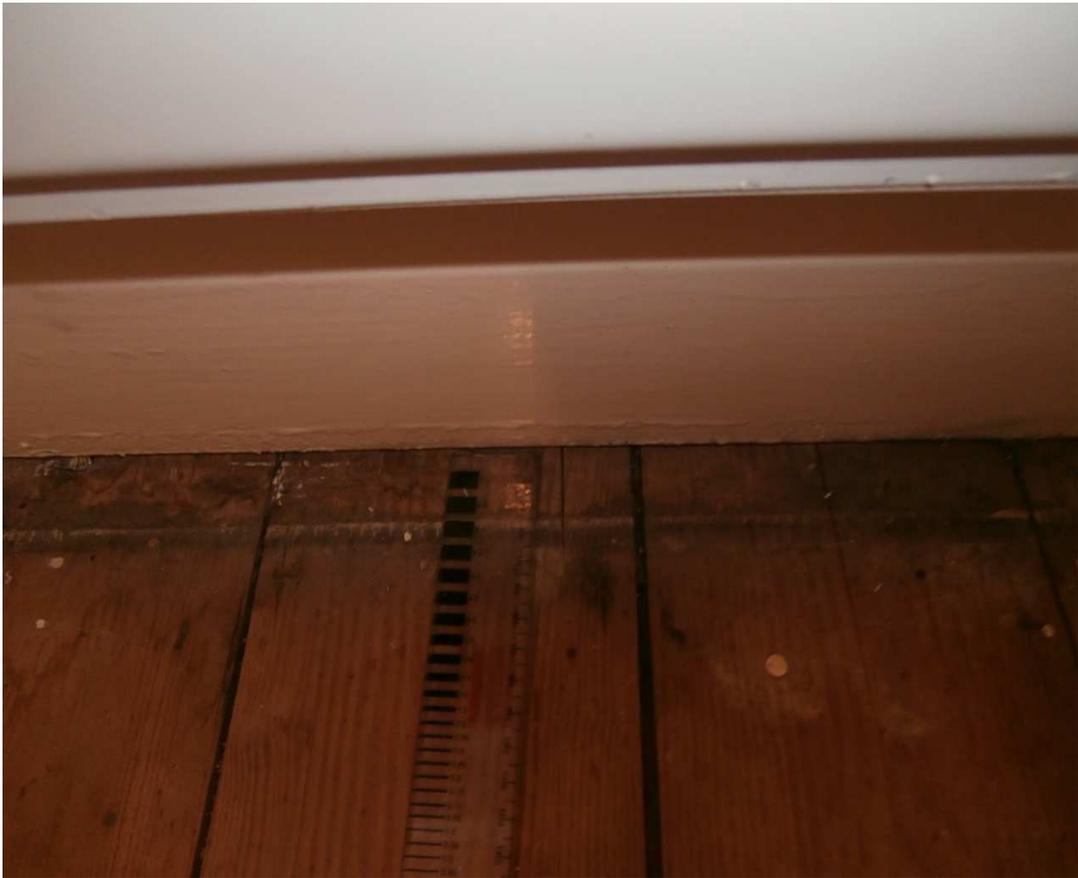
FIGURE 5

- The front elevation of the small bedroom is out of vertical by 10mm in 1.2m.
- The gable elevation of the small bedroom is out of vertical by 15mm in 1.2m.
- The front elevation of the small bedroom has moved laterally away from the floor boards of this room by between 15-20mm. See Figure 5 and recommendations.
- The gable wall within the small room has moved laterally significantly away from the room floorboards by between 30-40mm. See Figure 4 and recommendations.
- The suspended timber floor of the small room slopes to the front left hand corner of the room by between 10-15mm in 1.2m.

Lateral outward movement of the front elevation of the front left hand bedroom away from the bedroom floorboards.

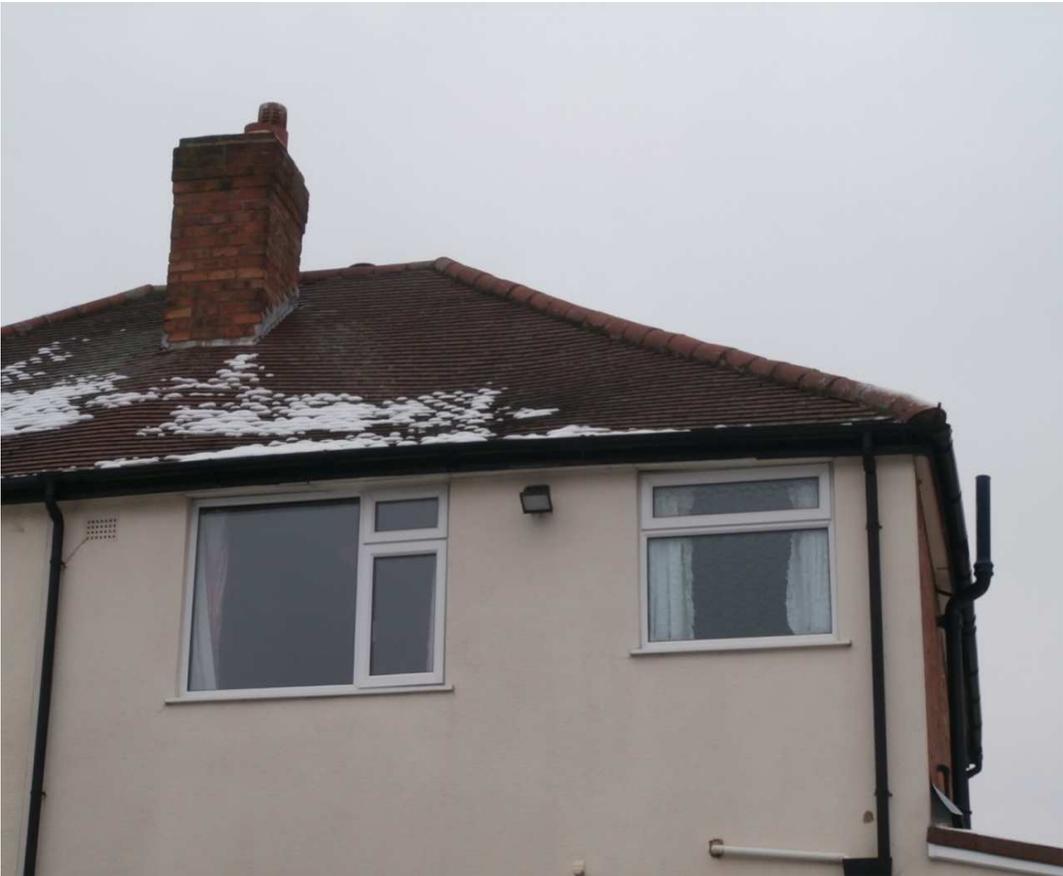
FIGURE 6

- The rear elevation of the property at the party wall area is out of vertical by 10mm in 1.2m at ground level and then by 20mm in 1.2m at roof eaves level.
- The rear elevation at the rear left hand corner of the house is out of vertical by 15mm in 1.2m at ground level and then by 40mm in 1.2m at roof eaves level.
- There is a significant bowing to the rear elevation of the house in the central area of the property at roof eaves level.
- The central area of the house is out of vertical by 10mm in 1.2m at ground level and then by between 20-30mm in 1.2m at roof eaves level.
- There is severe sag to the roof tiles of the property in the central area of the loft space and against the party wall. See Figure 6 and recommendations.
- There is a moderate slope to the roof ridge tiles away from the party wall.

Severe sagging to the roof structure of the house looking from the rear elevation.

Within the loft space of that property there is evidence of substantial roof spread having caused damage to the party wall in its central area. The roof purlins are very poorly supported and have twisted significantly. In the section below I will be recommending that some seven vertical supports are added to the front, rear and gable elevation purlins. Triangulation members should also be introduced to the front, rear and gable elevations of the loft space tying the roof rafters to the ceiling joists. The substantial cracking to the party wall within the loft space area should be repaired with a masonry beam.

Within the loft space of the property substantial roof strengthening works are required. Some seven vertical supports are required to the front, gable and rear roof purlins. Triangulation members are needed to the front, gable and rear of the loft space tying the roof rafters to the ceiling joists. The large cracks present to the party wall should be strengthened with a masonry beam.

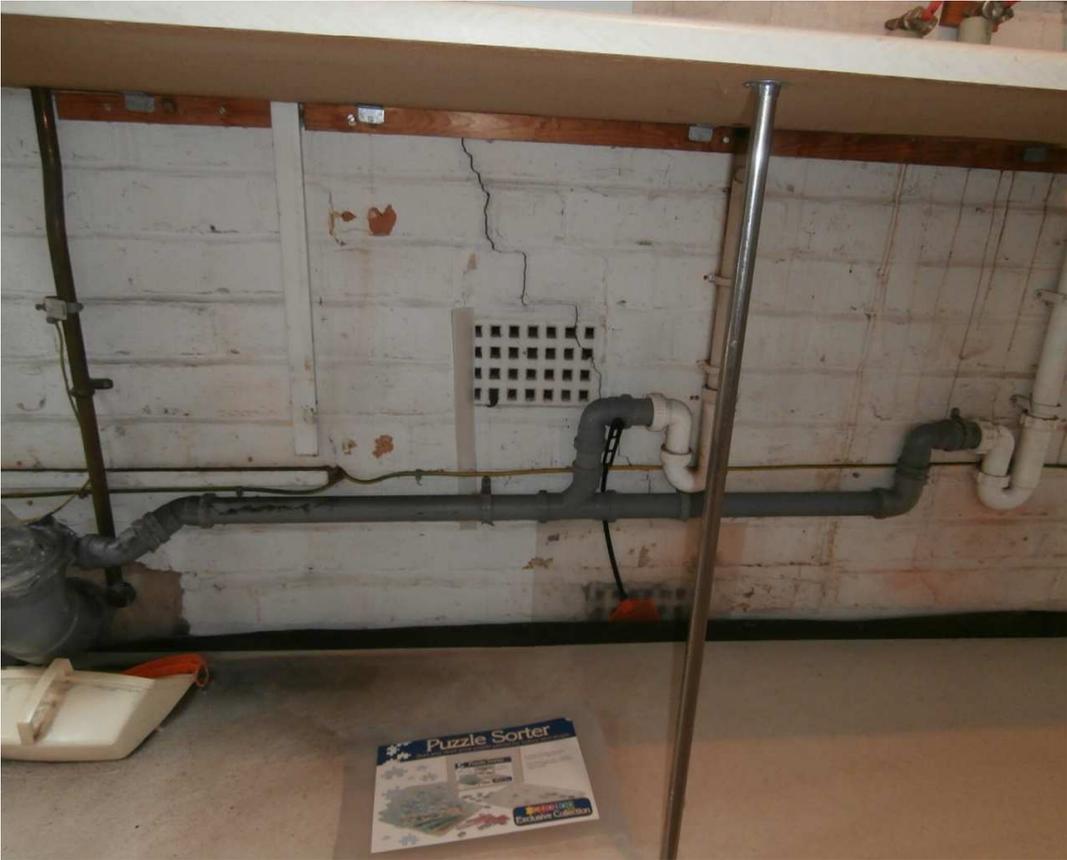
- The front left hand corner of the gable wall is out of vertical by 10mm in 1.2m.
- There is a diagonal crack to the front left hand corner at low level measuring 1mm in width approximately 8 brick courses long.
- The central area of the gable wall is significantly out of vertical by some 30mm in 1.2m at ground level.
- The rear left hand corner of the gable wall is out of vertical by 20mm in 1.2m at ground level.
- There has been significant re-pointing to the gable wall above the landing window and below the landing window.
- Cracks have also been re-filled directly above the pantry window. These cracks were approx. 10mm in width.
- There are diagonal cracks 1-2mm in width below the pantry window approximately 12 courses in length.

FIGURE 7
Diagonal cracking to the gable wall at low level in its central area.

I concur with the building surveyor's findings that the gable elevation of the property is suffering from historic and ongoing subsidence problems. The cause of the subsidence appears to be defective drains washing away fines from below the property's foundation. Drain repairs need to be completed as per the drainage survey recommendations. Masonry reinforcement type of repairs should then be completed to the elevation externally and internally.

It is important that the drainage repairs recommended along the gable elevation of this property are completed. Once drainage repairs are carried out building repairs to the gable wall should comprise masonry reinforcement of the cracks present at both ground level and first floor levels.

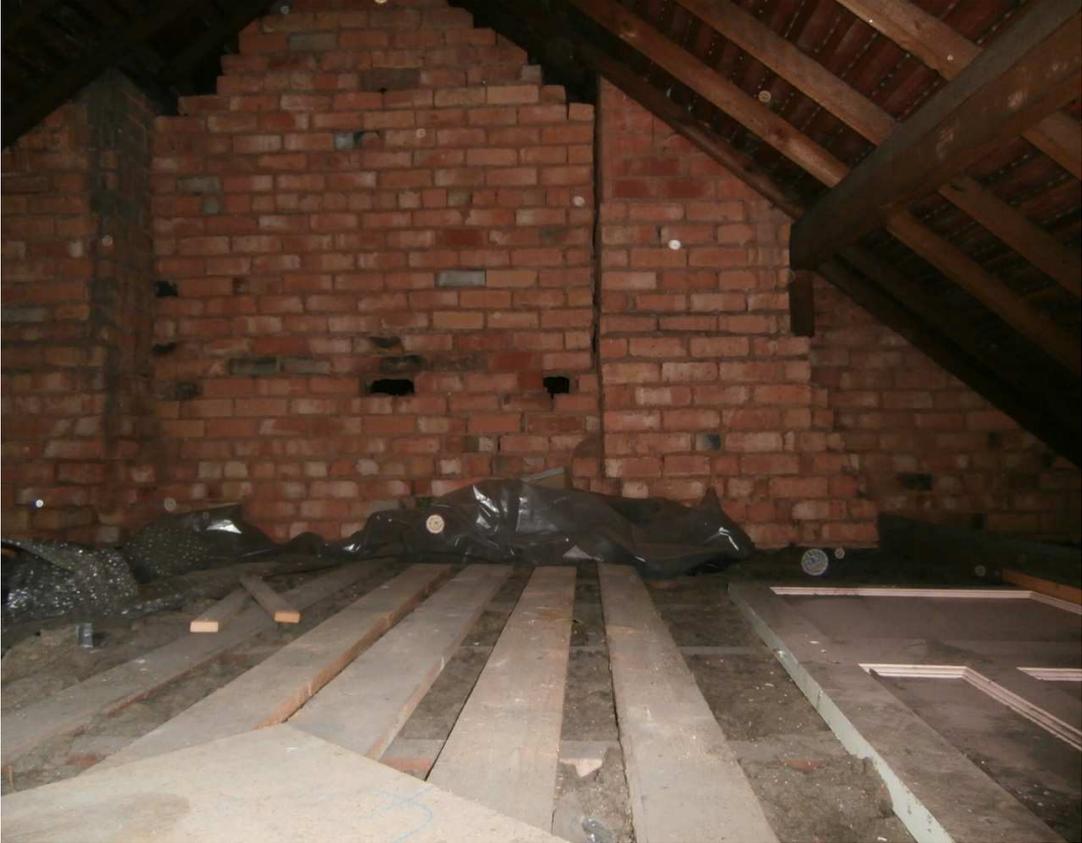
- There are cracks to the party wall measuring between 10-20mm in width immediately to the rear of the front chimney stack. See Figure 8 and recommendations.
- There is a diagonal crack immediately to the rear of the front chimney breast. See Figure 9 and recommendations.
- There is severe twisting to the gable elevation roof purlin. See Figure 10 and recommendations.
- There is moderate twisting and a substantial crack to the front roof purlin. See Figure 11 and recommendations.
- All the roof purlins are very poorly supported throughout the entire loft space area. See recommendations.

FIGURE 8
Severe vertical crack to brickwork of the party wall of the loft space immediately to the rear of the front chimney breast.
The front chimney breast is leaning in a forward direction.

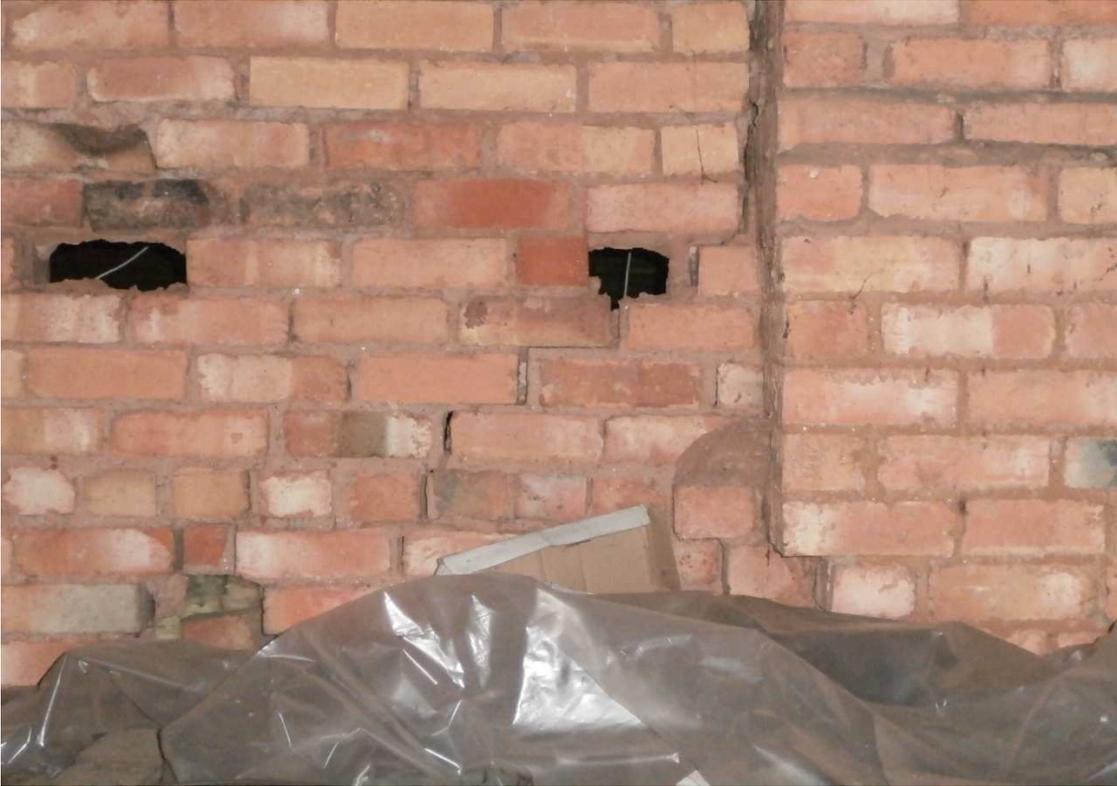
FIGURE 9
Diagonal cracking to the party wall immediately to the rear of the front chimney breast.

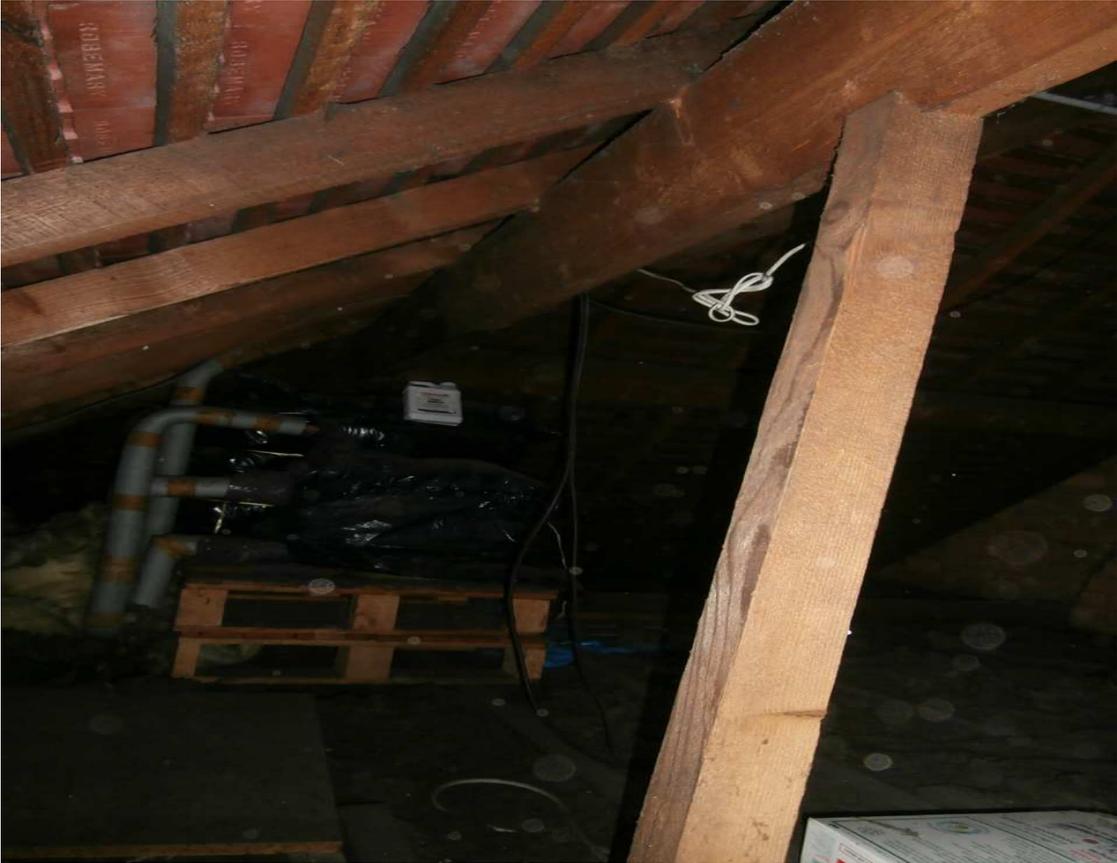
FIGURE 10
Severe twisting to the gable elevation roof purlin.

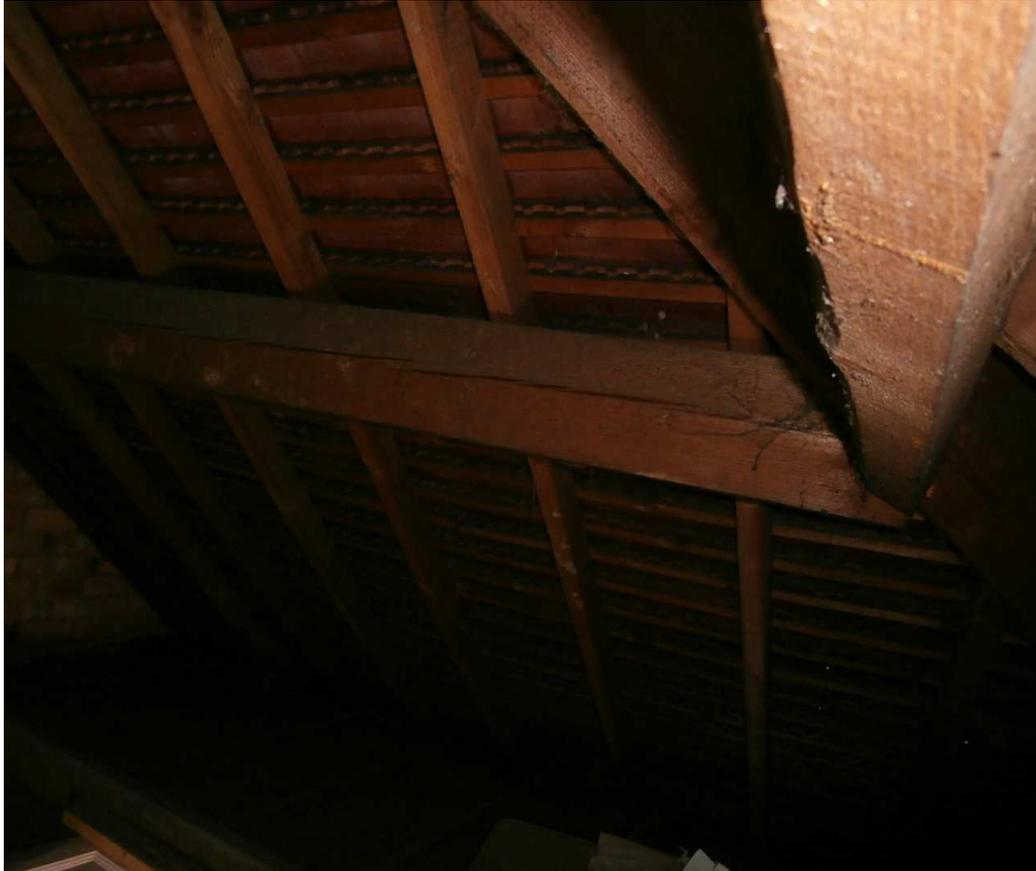
FIGURE 11

Twisting and substantial cracking to the front elevation roof purlin showing poor vertical supports to that structure.
