SPECIFIC ENGINEERS REPORT

Marcel Furet

Stourbridge West Midlands

Date: 25 April 2014

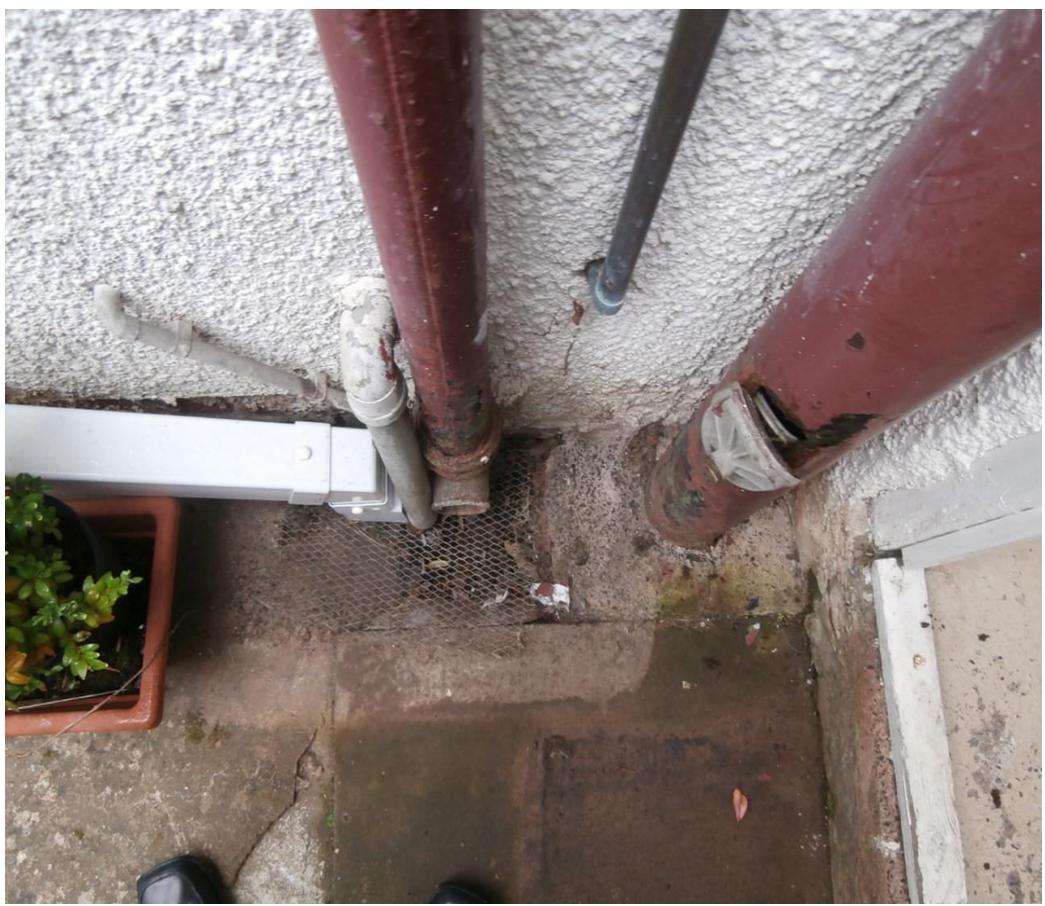
FIGURE 3 Soil and vent pipe and kitchen gully.

- The front left hand corner of the left hand elevation is fairly vertical at both ground floor and first floor level.
- The central area of the left hand elevation is fairly vertical at ground level.
- The soil and vent pipe has been cut to carry out a CCTV survey many years ago. See Figure 3 together with comments.
- The kitchen gully has not been replaced and is in a fair condition.
- The rear left hand corner of the left hand elevation is fairly vertical at both ground level and first floor level.
- The outbuilding flat roof is in a poor condition. See Figure 10 together with recommendations.

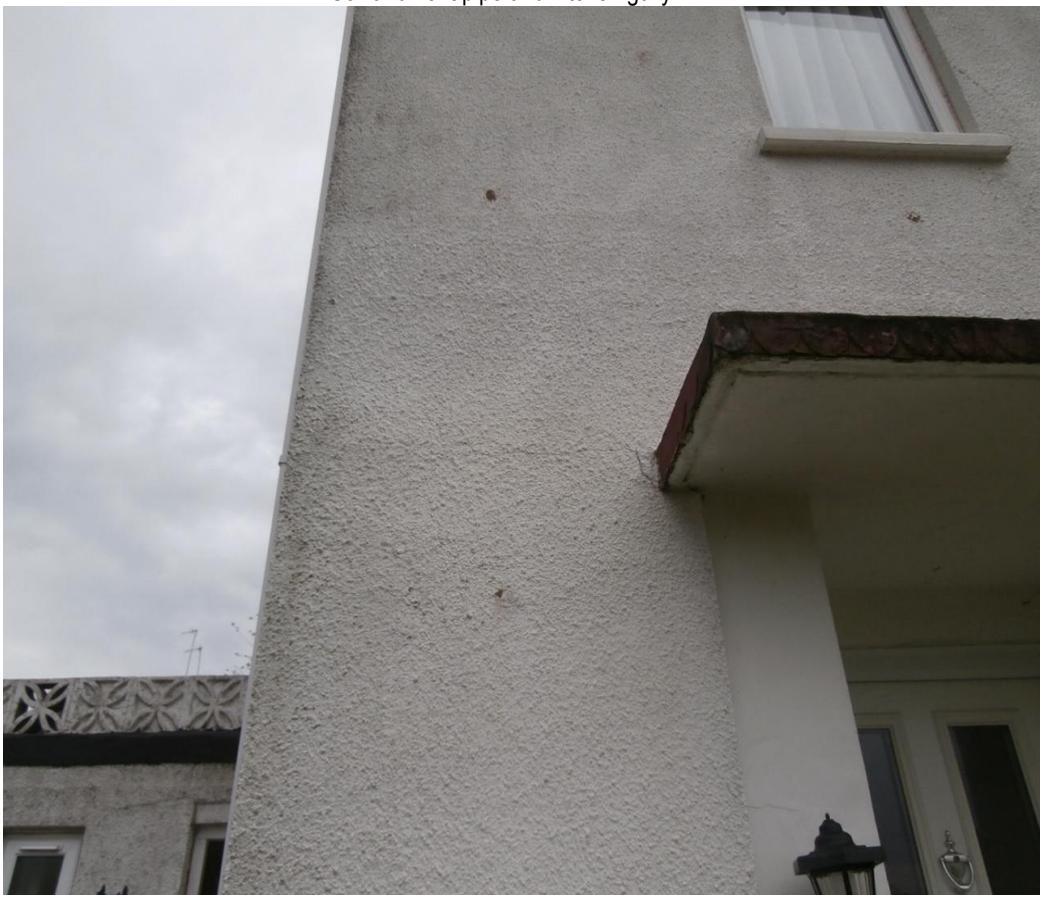
FIGURE 4 Horizontal crack to rendering to the front elevation to the left hand side of the entrance concrete canopy.

- The roof ridge tiles are fairly level in the central area.
- There is significant slope to the roof ridge tiles at the left hand elevation.
- There is a horizontal render crack 1-2mm in width to the left hand side of the entrance door canopy lintel. See Figure 4.

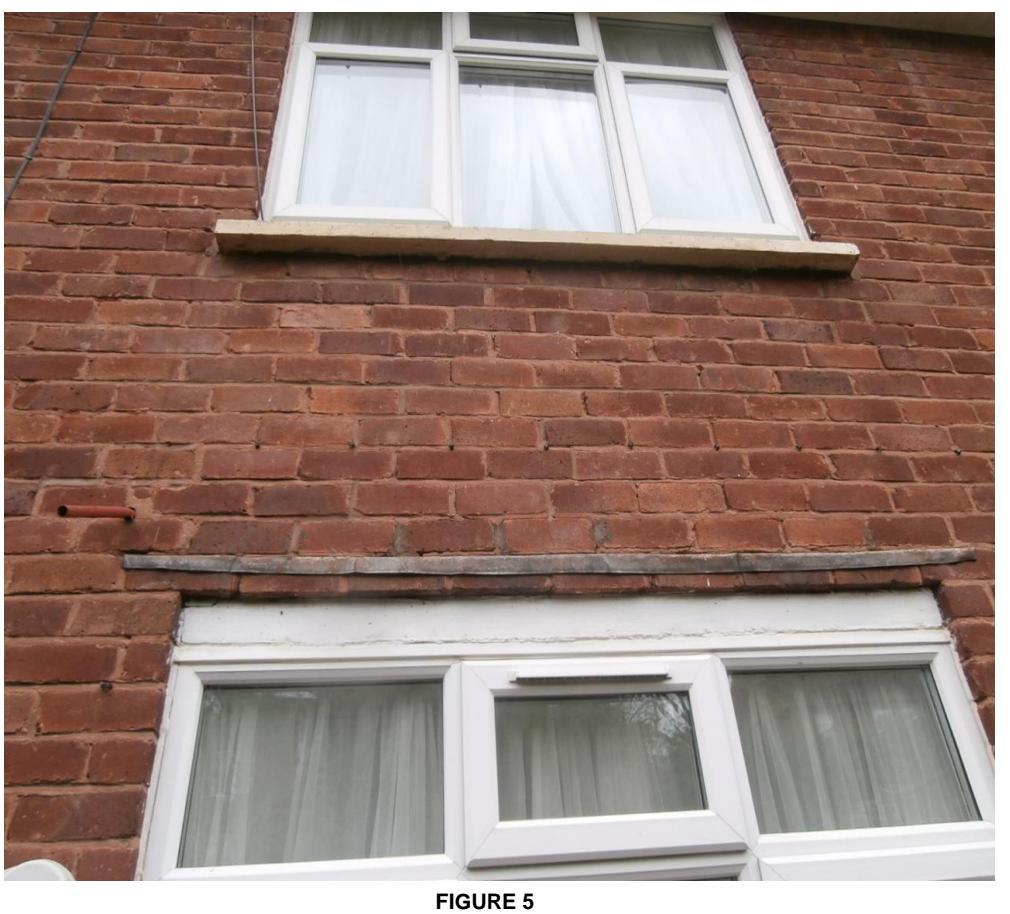
Cracking and settlement of brickwork to the rear elevation above the lounge window lintel.

I also concur with the surveyor regarding the lintel failures to the rear elevation above the lounge and kitchen windows. New lintels could be introduced alternatively heavy duty Helibars could be introduced above the brick soldier course providing support to brickwork above the lintels.

I recommend that long Helibars are introduced to the rear elevation of the house to adequately support brickwork above the lounge and kitchen window lintels. A 2.5m long Helibar should be introduced above the soldier course of the lounge lintel. A 2m long Helibar should be introduced above the soldier course of the kitchen window lintel. The areas above both lintels can then be re-pointed.

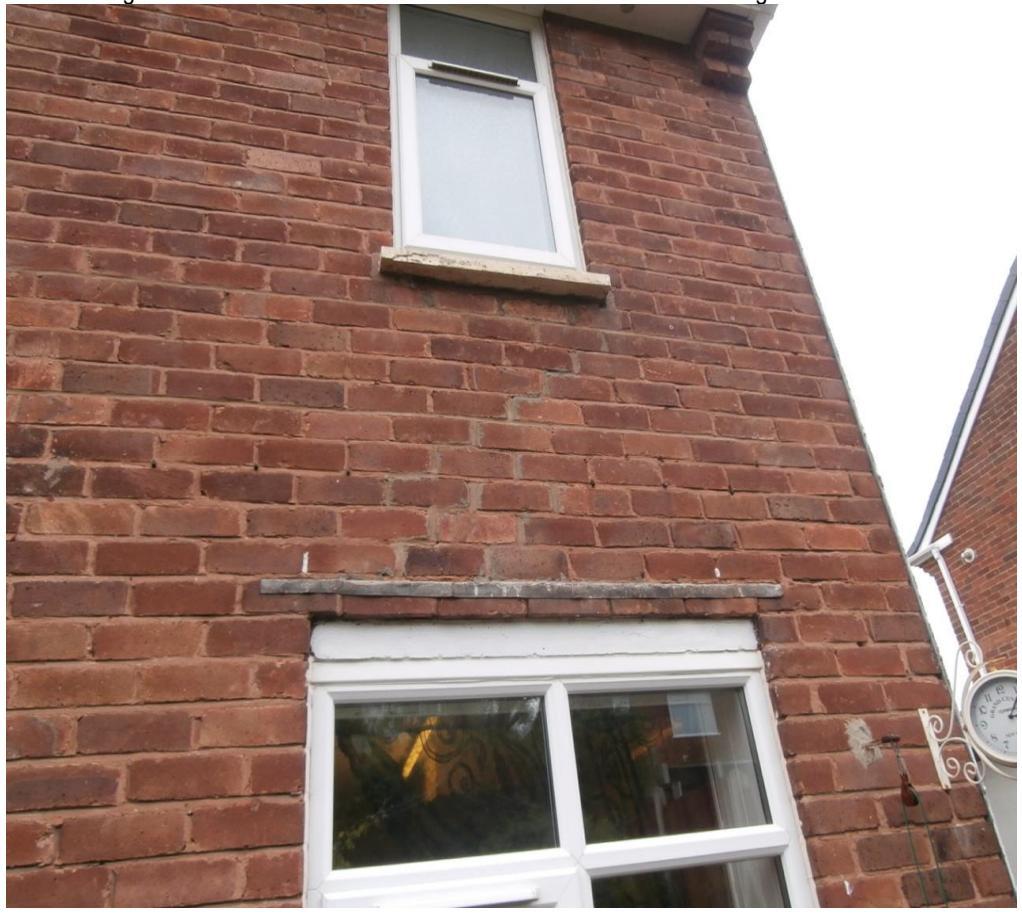
FIGURE 6 Cracking and displaced brickwork to the rear elevation above the kitchen window lintel.

- The rear elevation rear left hand corner is fairly vertical at ground level and out of vertical by 20mm at roof eaves level.
- The rear elevation of the central area is fairly vertical at both ground level and first floor level.
- The rear elevation within the rear right hand party wall is fairly vertical at both ground level and first floor level.
- There is a 1mm diagonal crack above the lounge window lintel up to the bedroom window. The brickwork within this area has settled onto the concrete lintel. The concrete lintel has been left too short. See Figure 5 together with recommendations.
- There is a 1mm diagonal crack above the kitchen window lintel up to the bathroom window this area has been previously re-pointed. The concrete lintel of this window has been left too short. See Figure 6 together with recommendations.

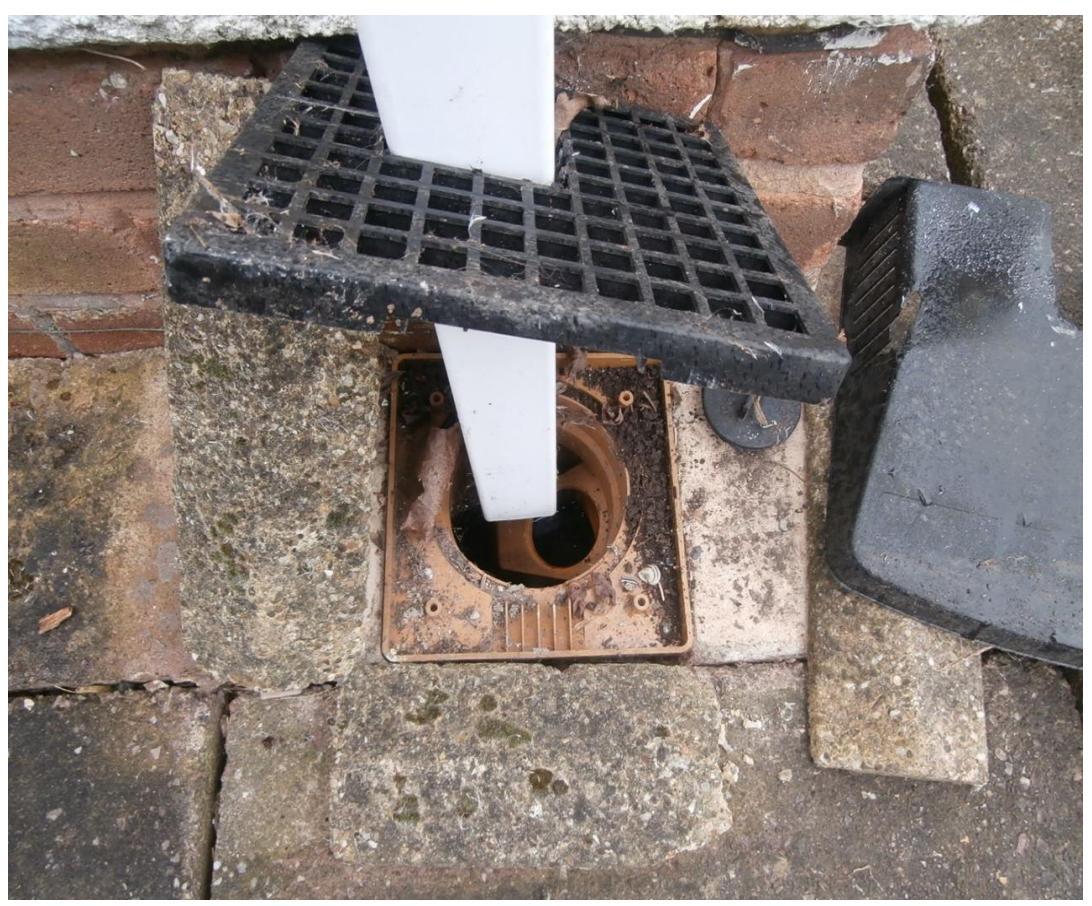
FIGURE 7 Roddable plastic gully installed to the front left hand corner of the house in circa 2005.

• The front left hand corner gully has been replaced with a plastic roddable gully. This is a storm drain which discharges into the storm sewer running parallel to the front elevation of the house. See Figure 7 together with comments.

I understand that a CCTV survey of the drains has recently been carried out. That survey confirms that the front left hand corner storm gully has been replaced. Additionally a short length of downstream drain has been lined onto the storm sewer which runs parallel to the front elevation of this house. To the rear of the house the soil and vent pipe and kitchen gully are in a fair condition. Some 4m to the rear of the soil and vent pipe the main foul sewer runs parallel to the rear elevation of this property. I understand that no major defects were found during the CCTV survey.

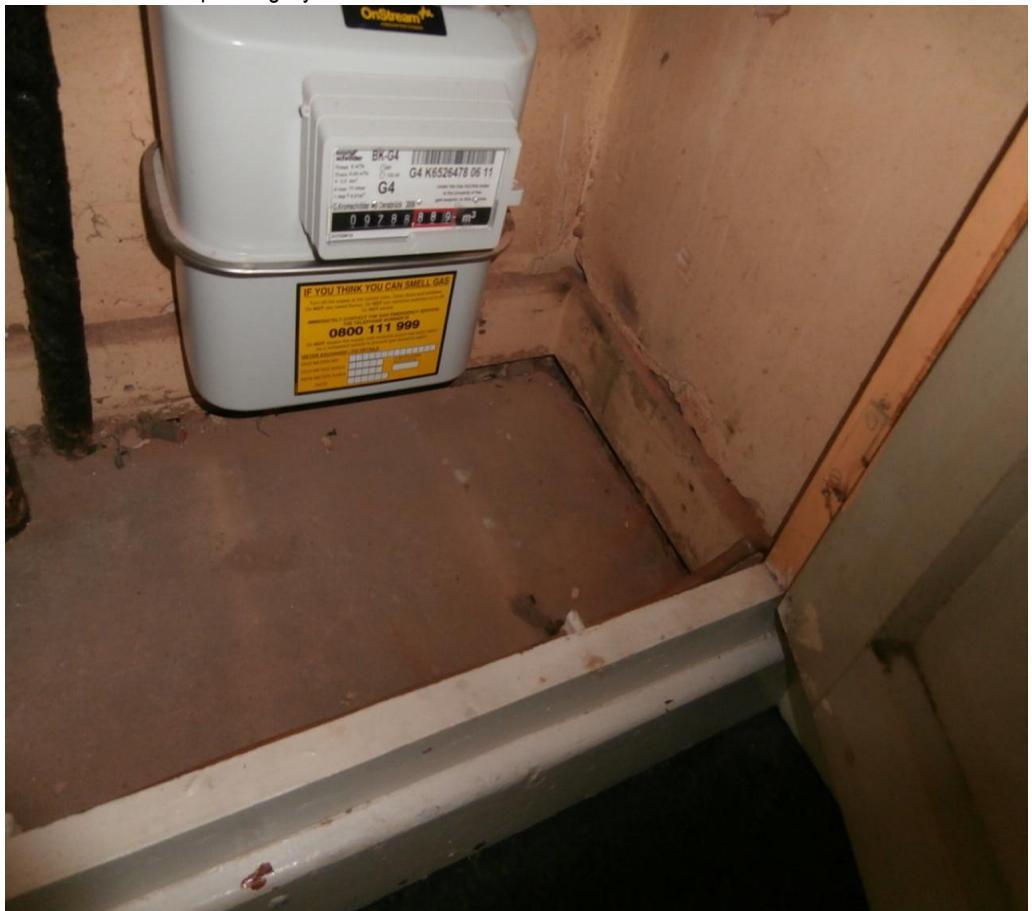
FIGURE 8 Settlement of the solid floor of the front left hand cupboard within the hallway.

- There is a 2-3mm diagonal crack to the front elevation of the front left hand meter cupboard.
- The solid floor within the front left hand meter cupboard has dropped by some 10mm away from the skirting boards. See Figure 8 together with recommendations.
- The stair left hand elevation is out of vertical by 1.5%.
- The hallway solid floor slopes by some 2% towards the front left hand corner.
- The door frame from the hallway leading to the lounge is fairly square.

The solid floor of the meter cupboard should be re-screeded to level. An indemnity policy should be put in place for the poor installation of the RSJ lintel between the front and rear sitting rooms of the lounge.

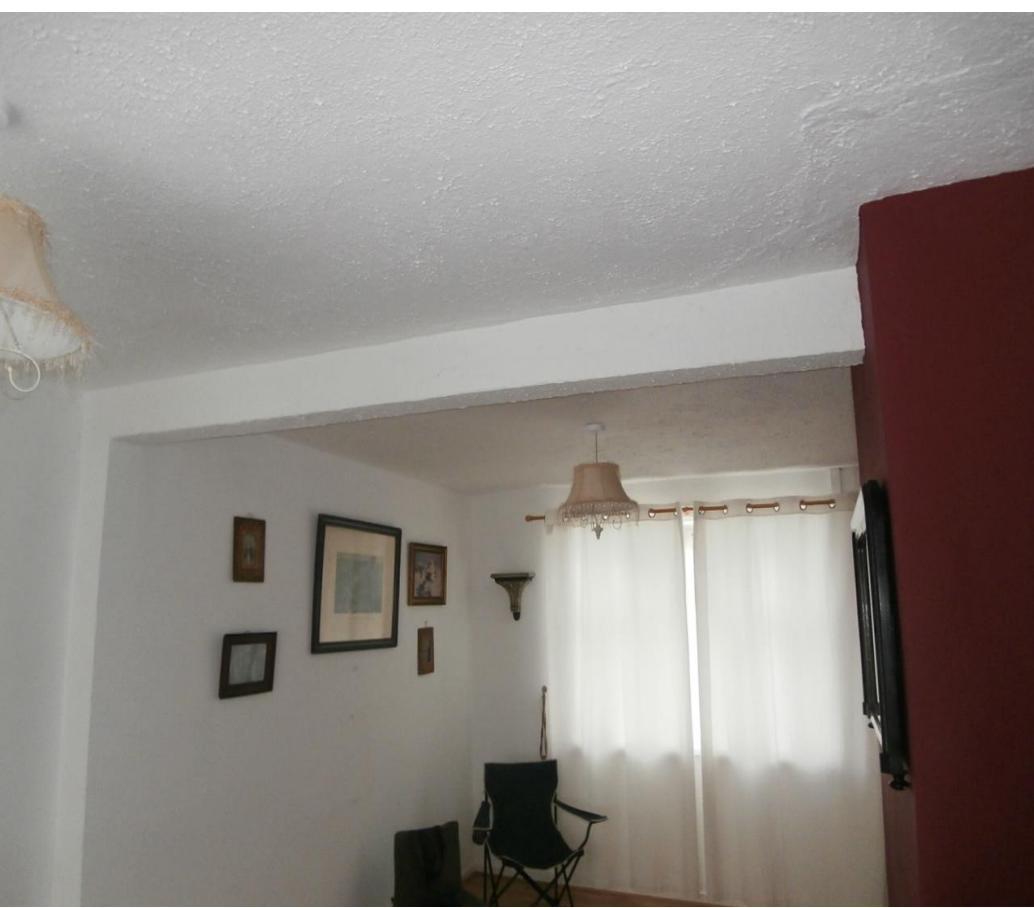
FIGURE 9 RSJ lintel introduced between the front and rear sitting rooms of the lounge which is supported by the chimney breast.

- The front elevation of the lounge is out of vertical by 1%.
- The party wall of the lounge is fairly vertical.
- The rear elevation of the lounge is fairly vertical.
- An RSJ lintel has been installed between the front and rear sitting rooms of the lounge. The lintel is supported by the hallway partition wall and by the chimney breast. See Figure 9 showing the beam installation.

I am concerned about the installation of the RSJ lintel between the front and rear sitting rooms of the lounge. This lintel installation does not meet building regulation standards as the lintel is supported in part by the chimney breast. I will be advising my client to obtain an indemnity insurance policy for the poor installation of this lintel.

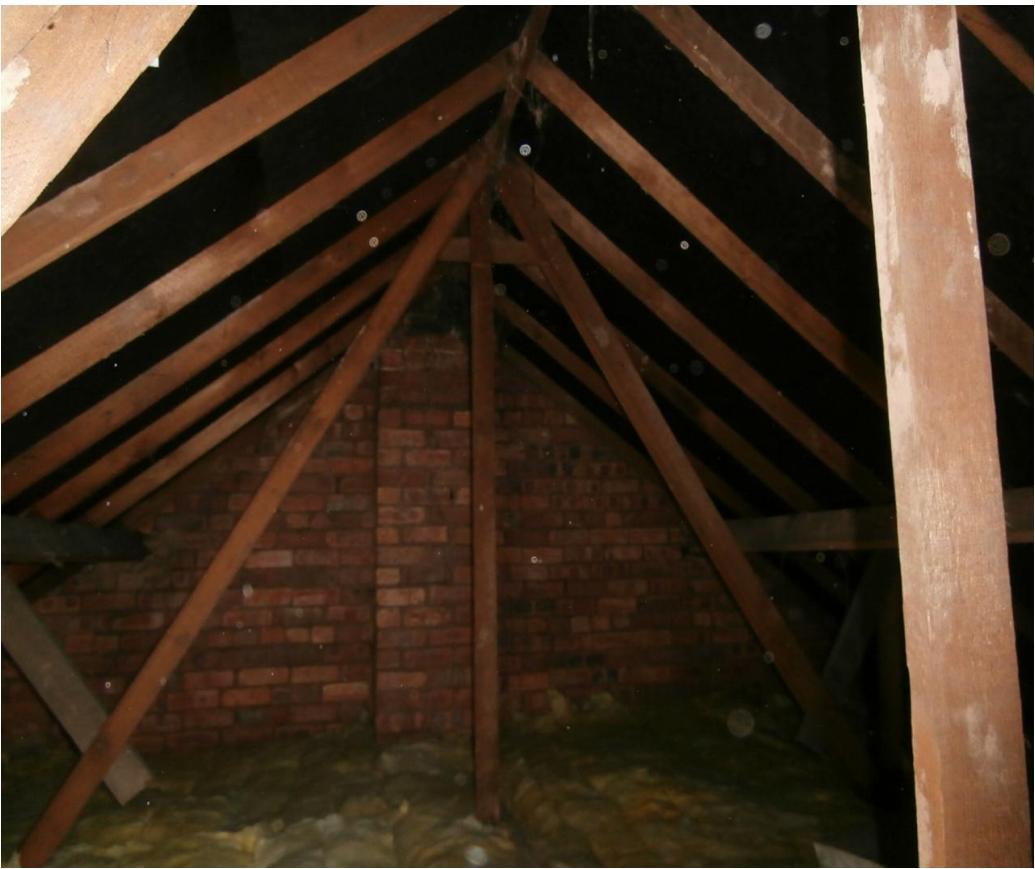
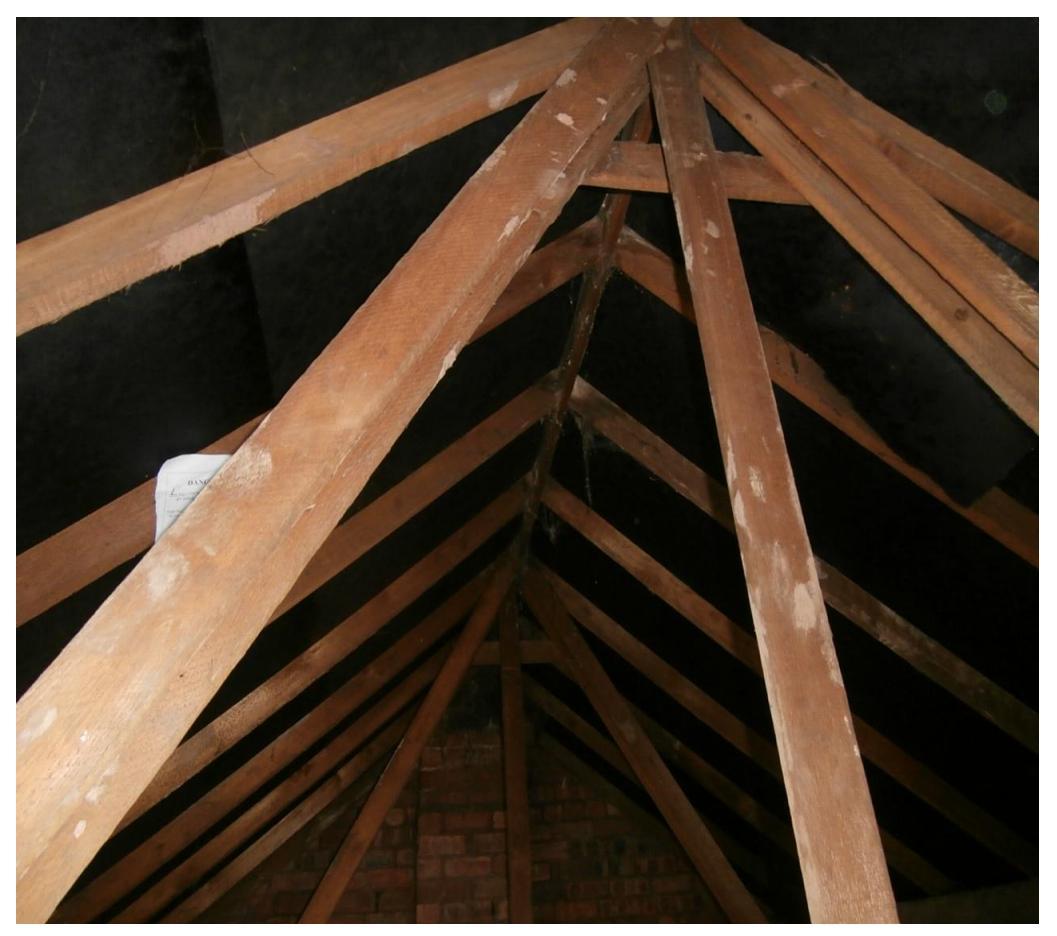
- Triangulation configuration has been installed within the loft space supporting the roof purlins. Two large triangulation members are present which adequately support the purlins. See Figures 11 and 12.
- The front and rear roof purlins have sagged moderately in their central areas.

FIGURE 11 Good supports to the roof timbers and purlins.

FIGURE 12 Good supports to the roof timbers and purlins
